RECLAMATION

Lower Colorado River

**Challenges And Control Activities
For Invasive Mussels**

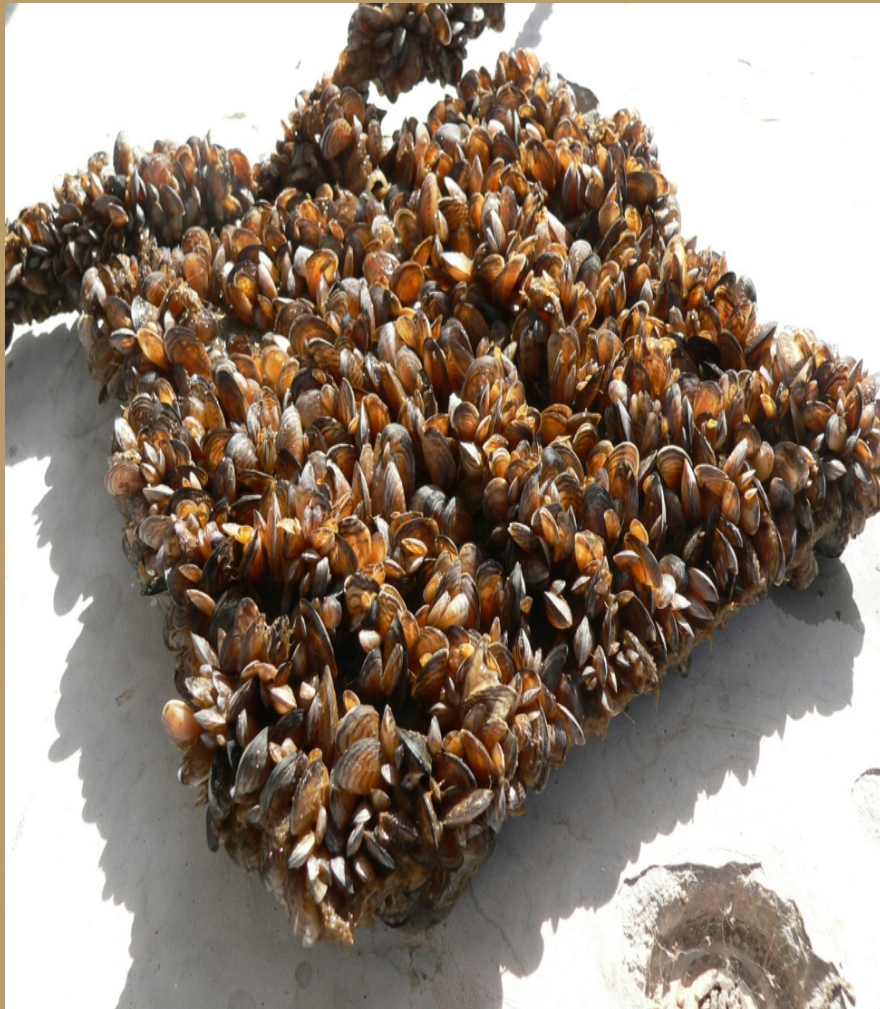
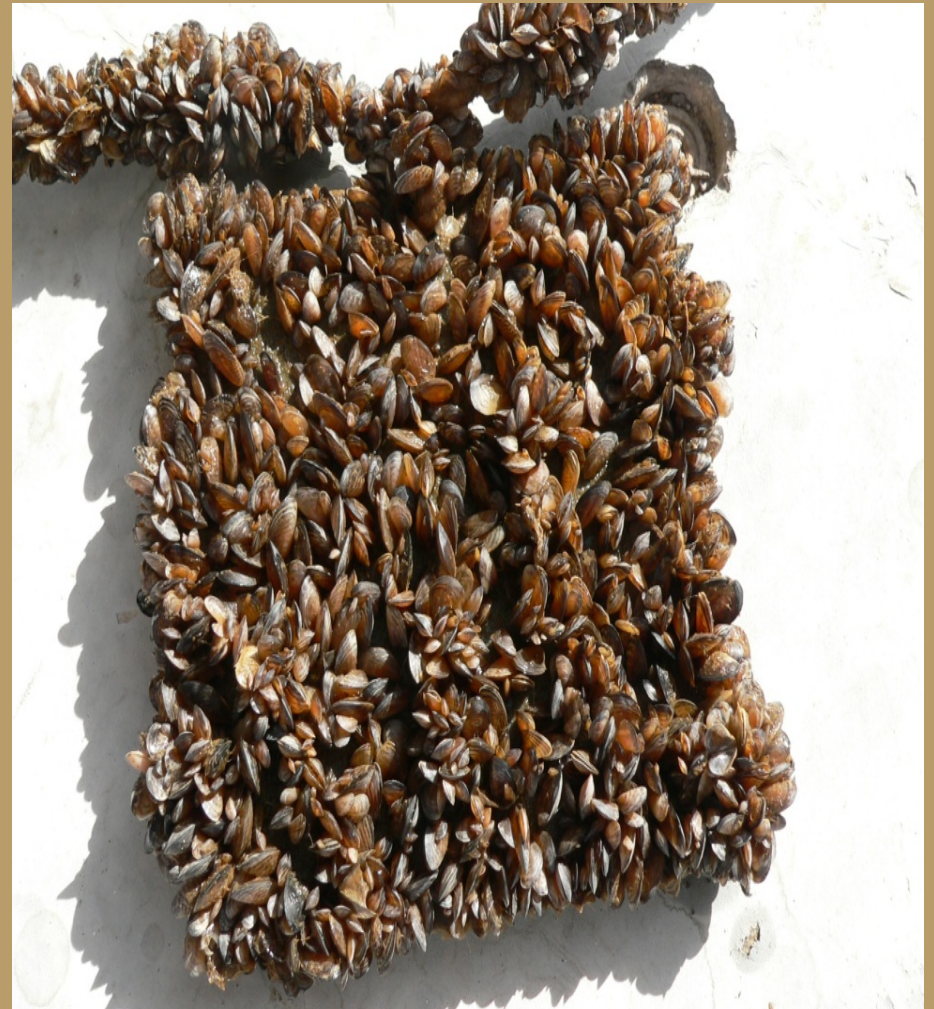
Sampling Plates at Parker Dam

November 11/07 – 6 Weeks of Settlement

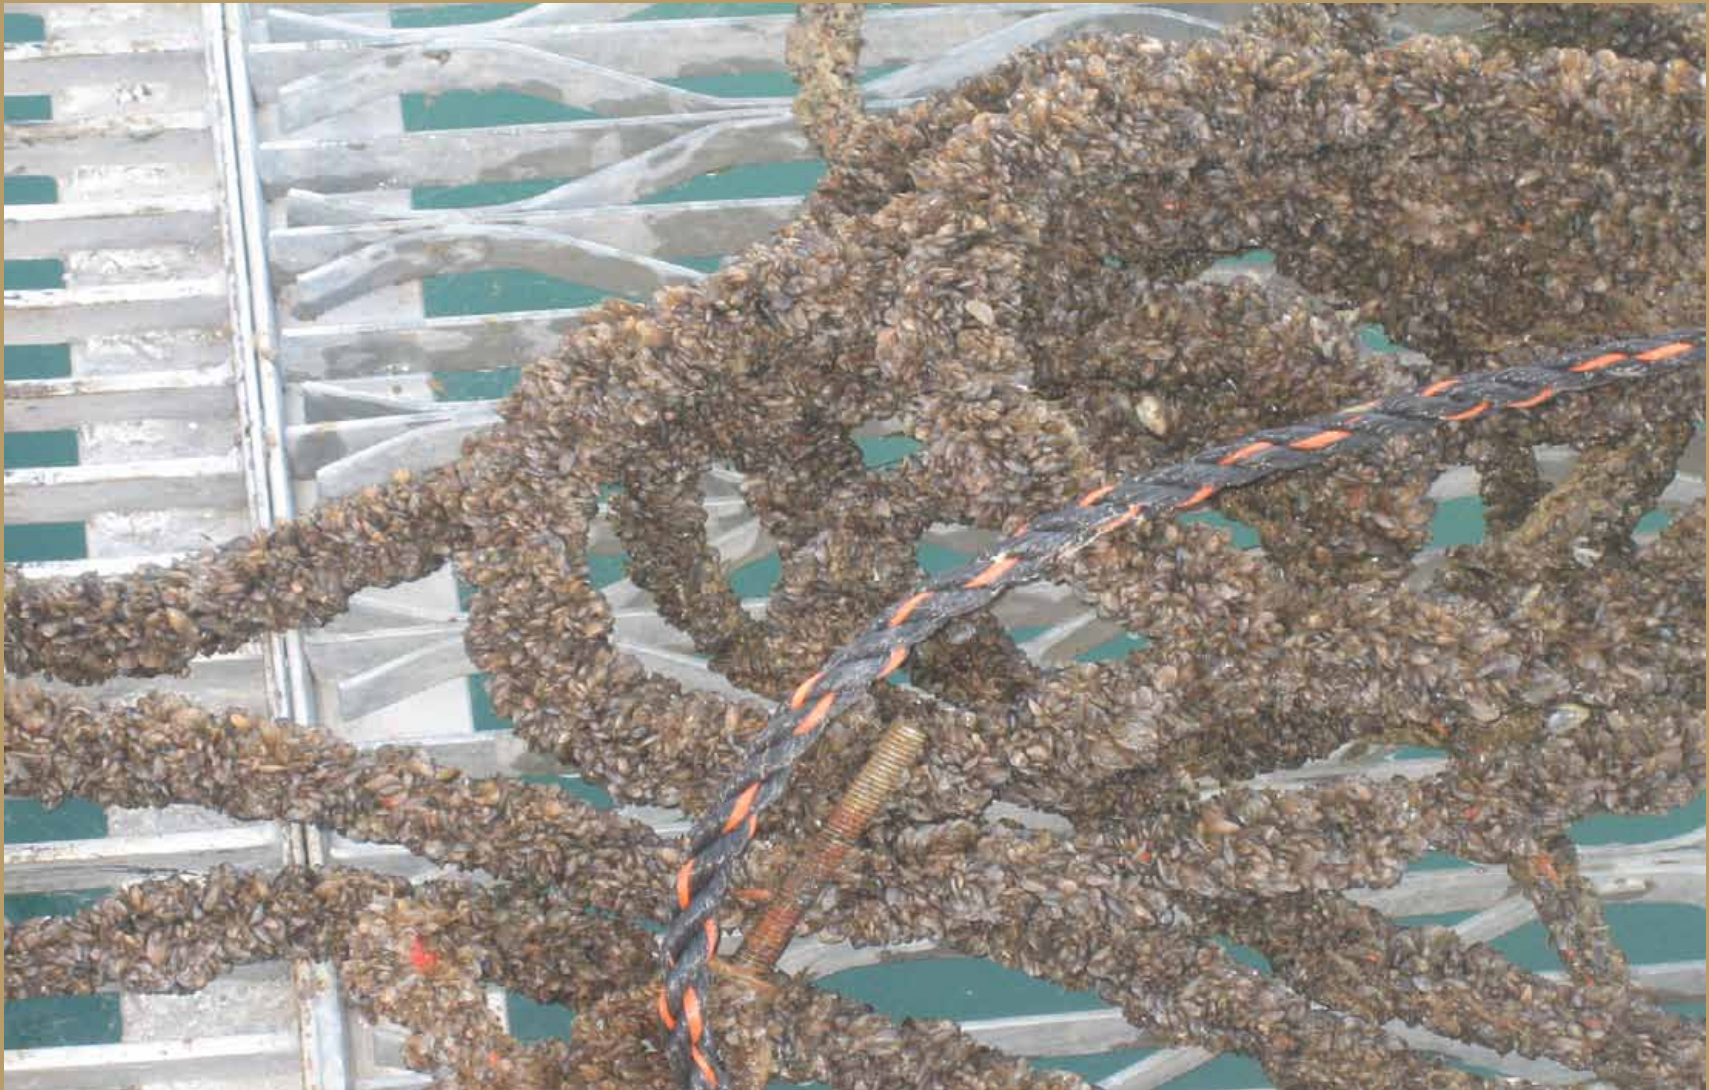
Parker Dam Monitoring Plate Rope September 2008

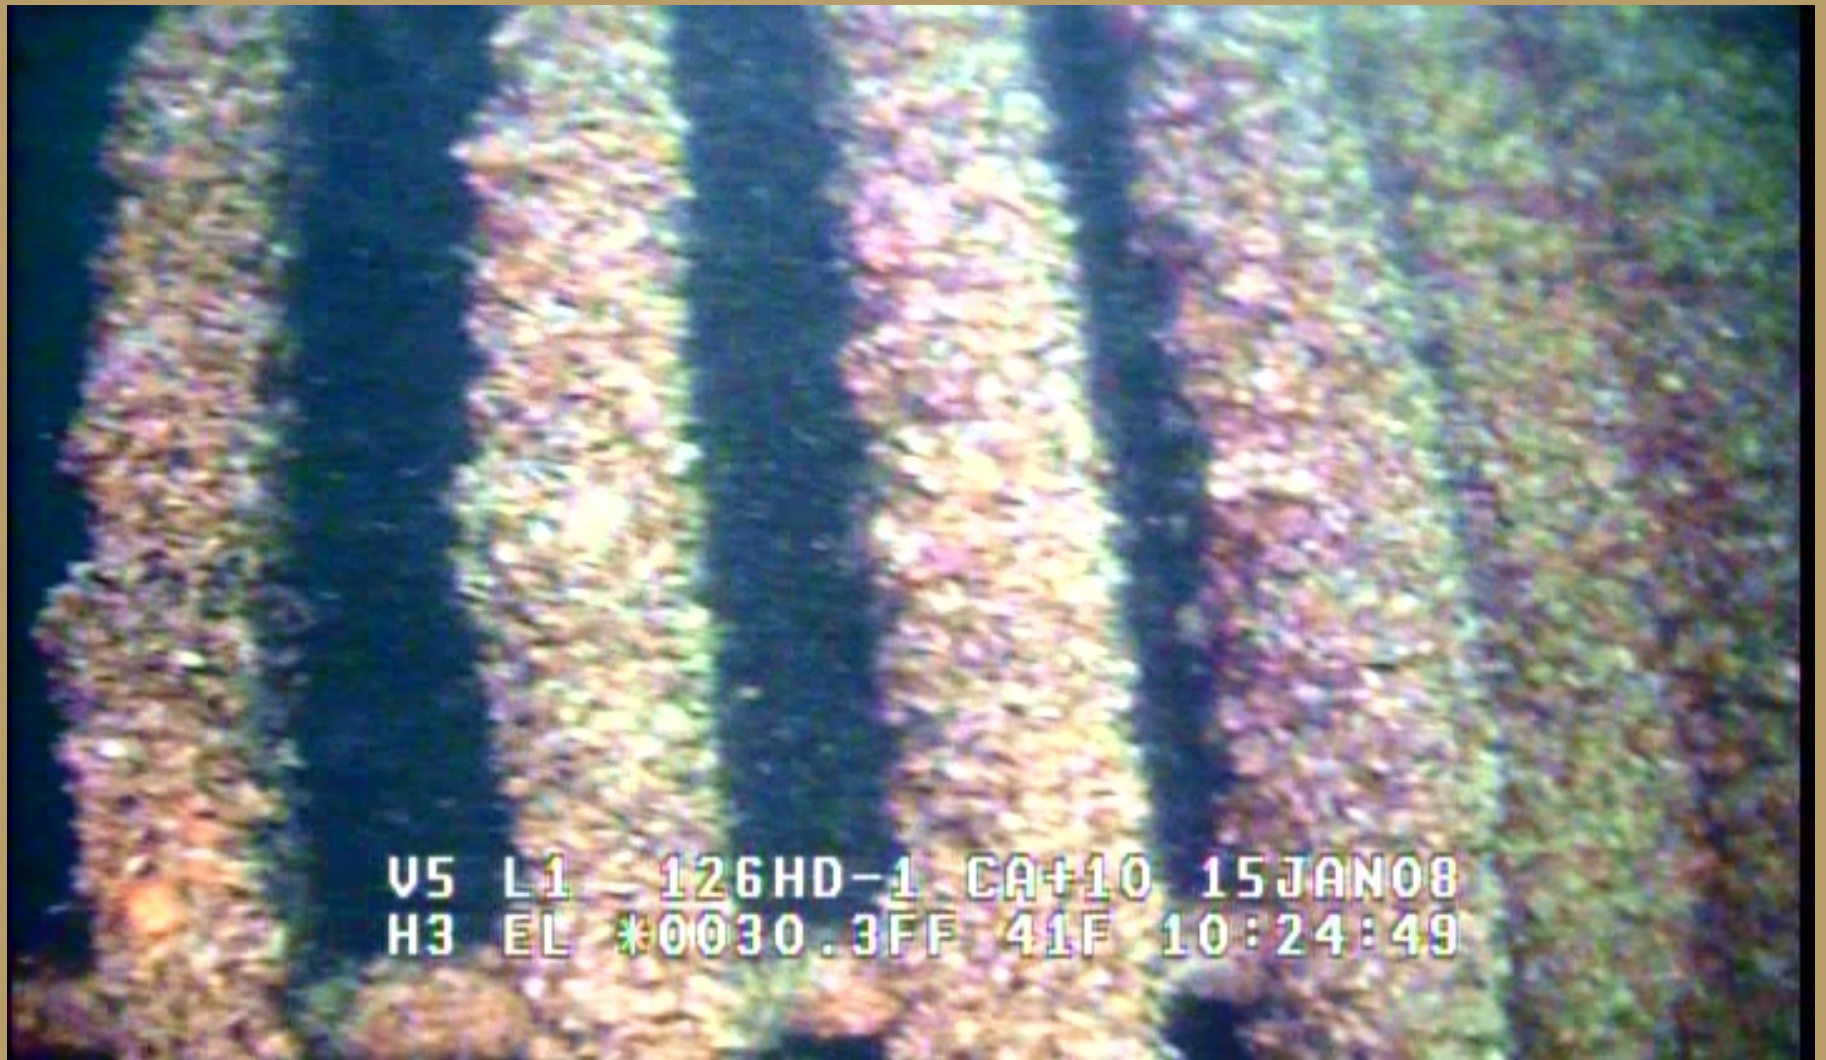
Underwater Photo – Trash Rack Parker Dam - January 15, 2008

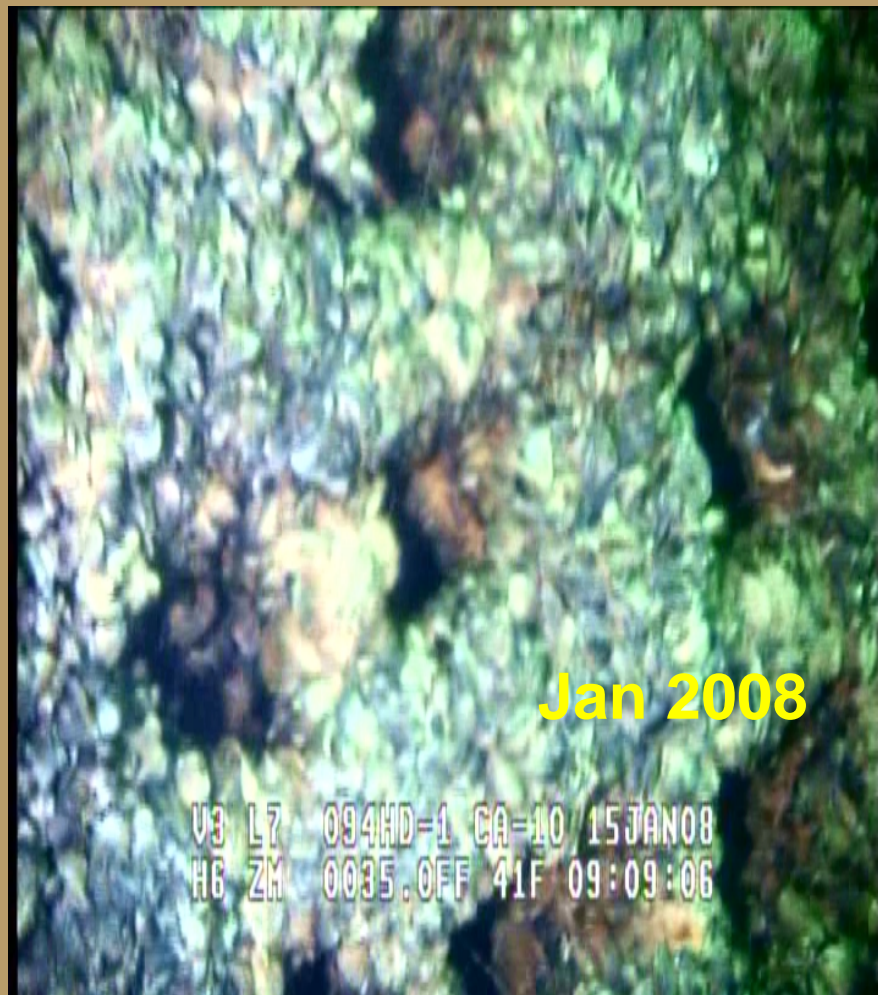
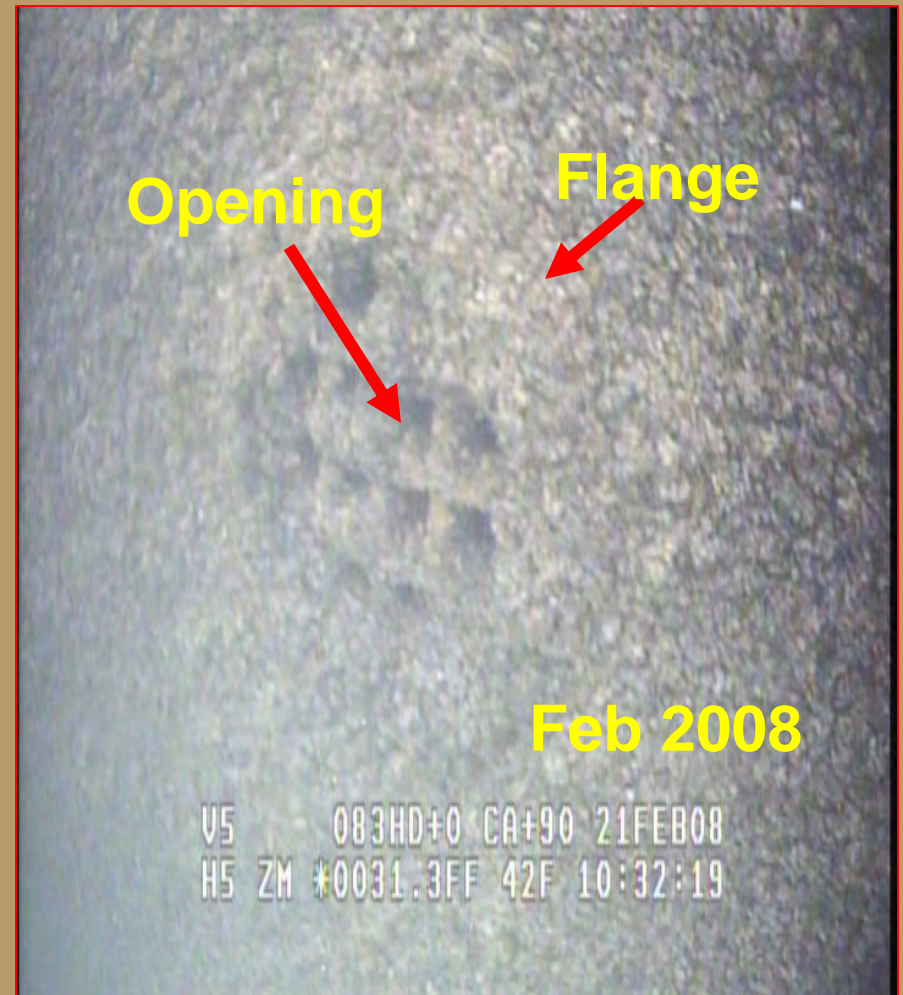
Underwater Photo – Domestic Water Intake Parker Dam

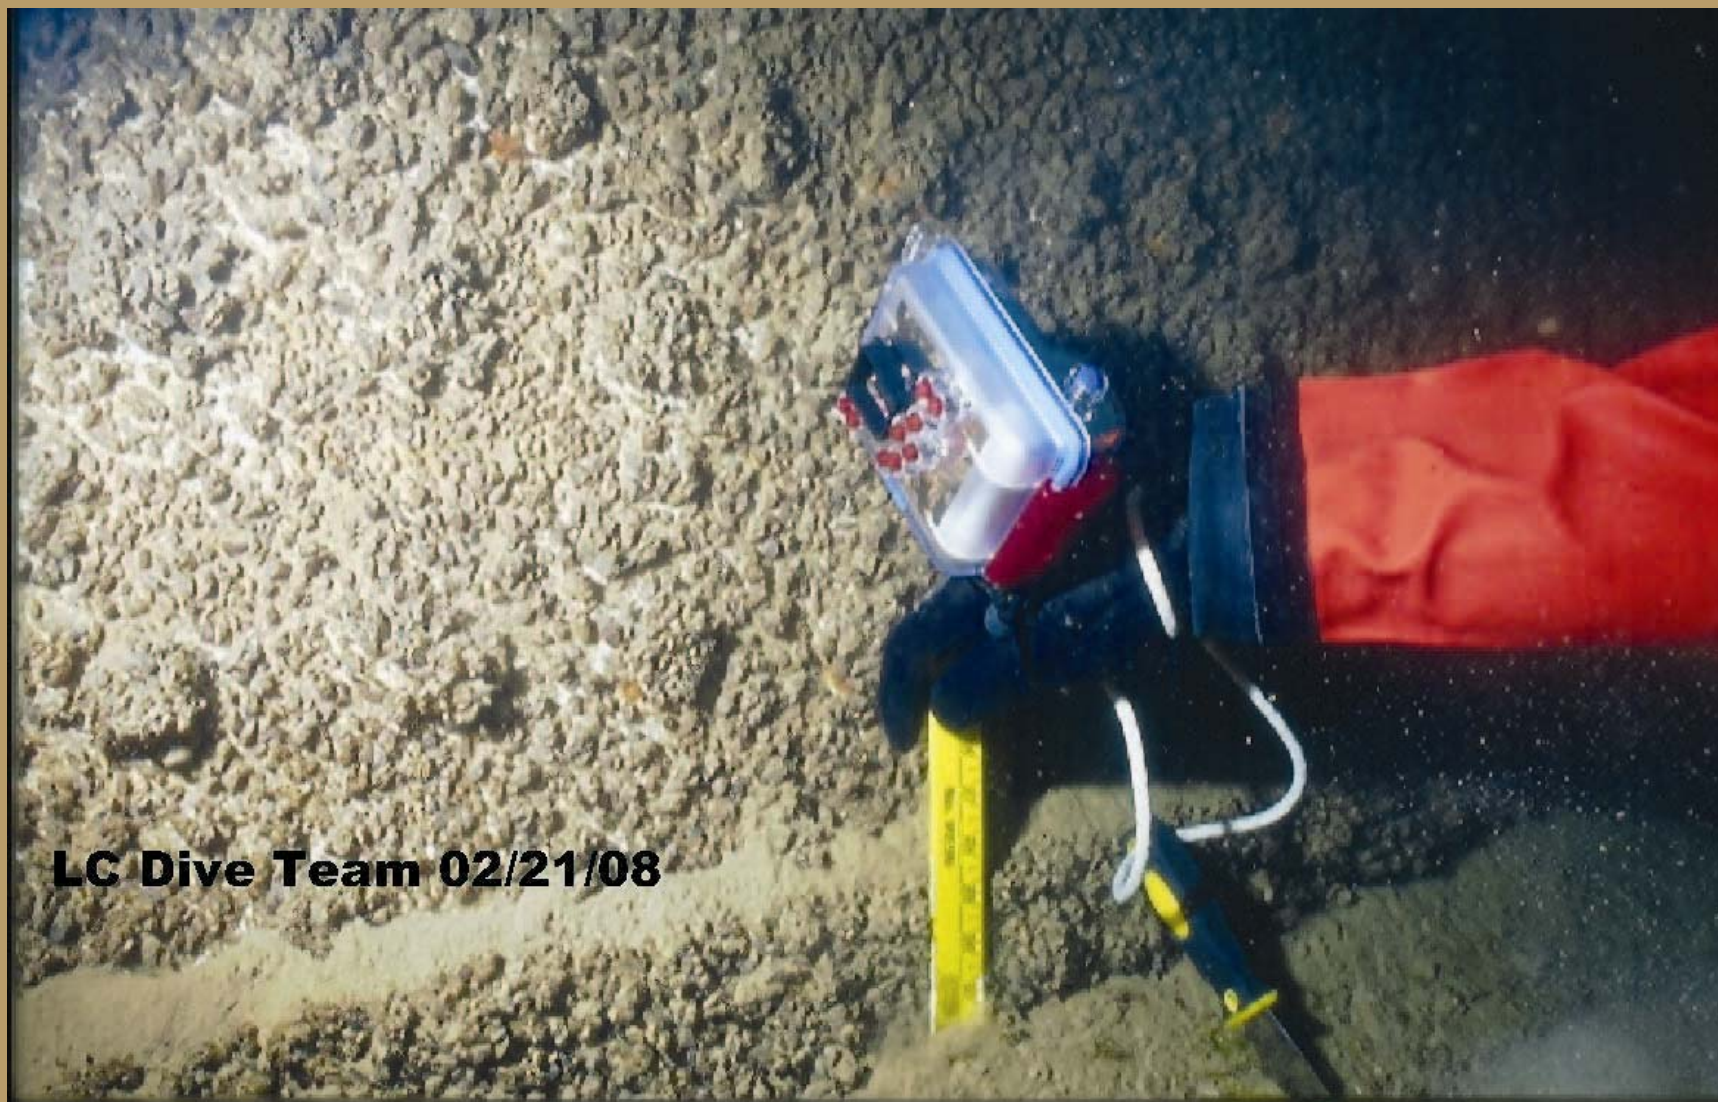
Spillway Gates – Parker Dam

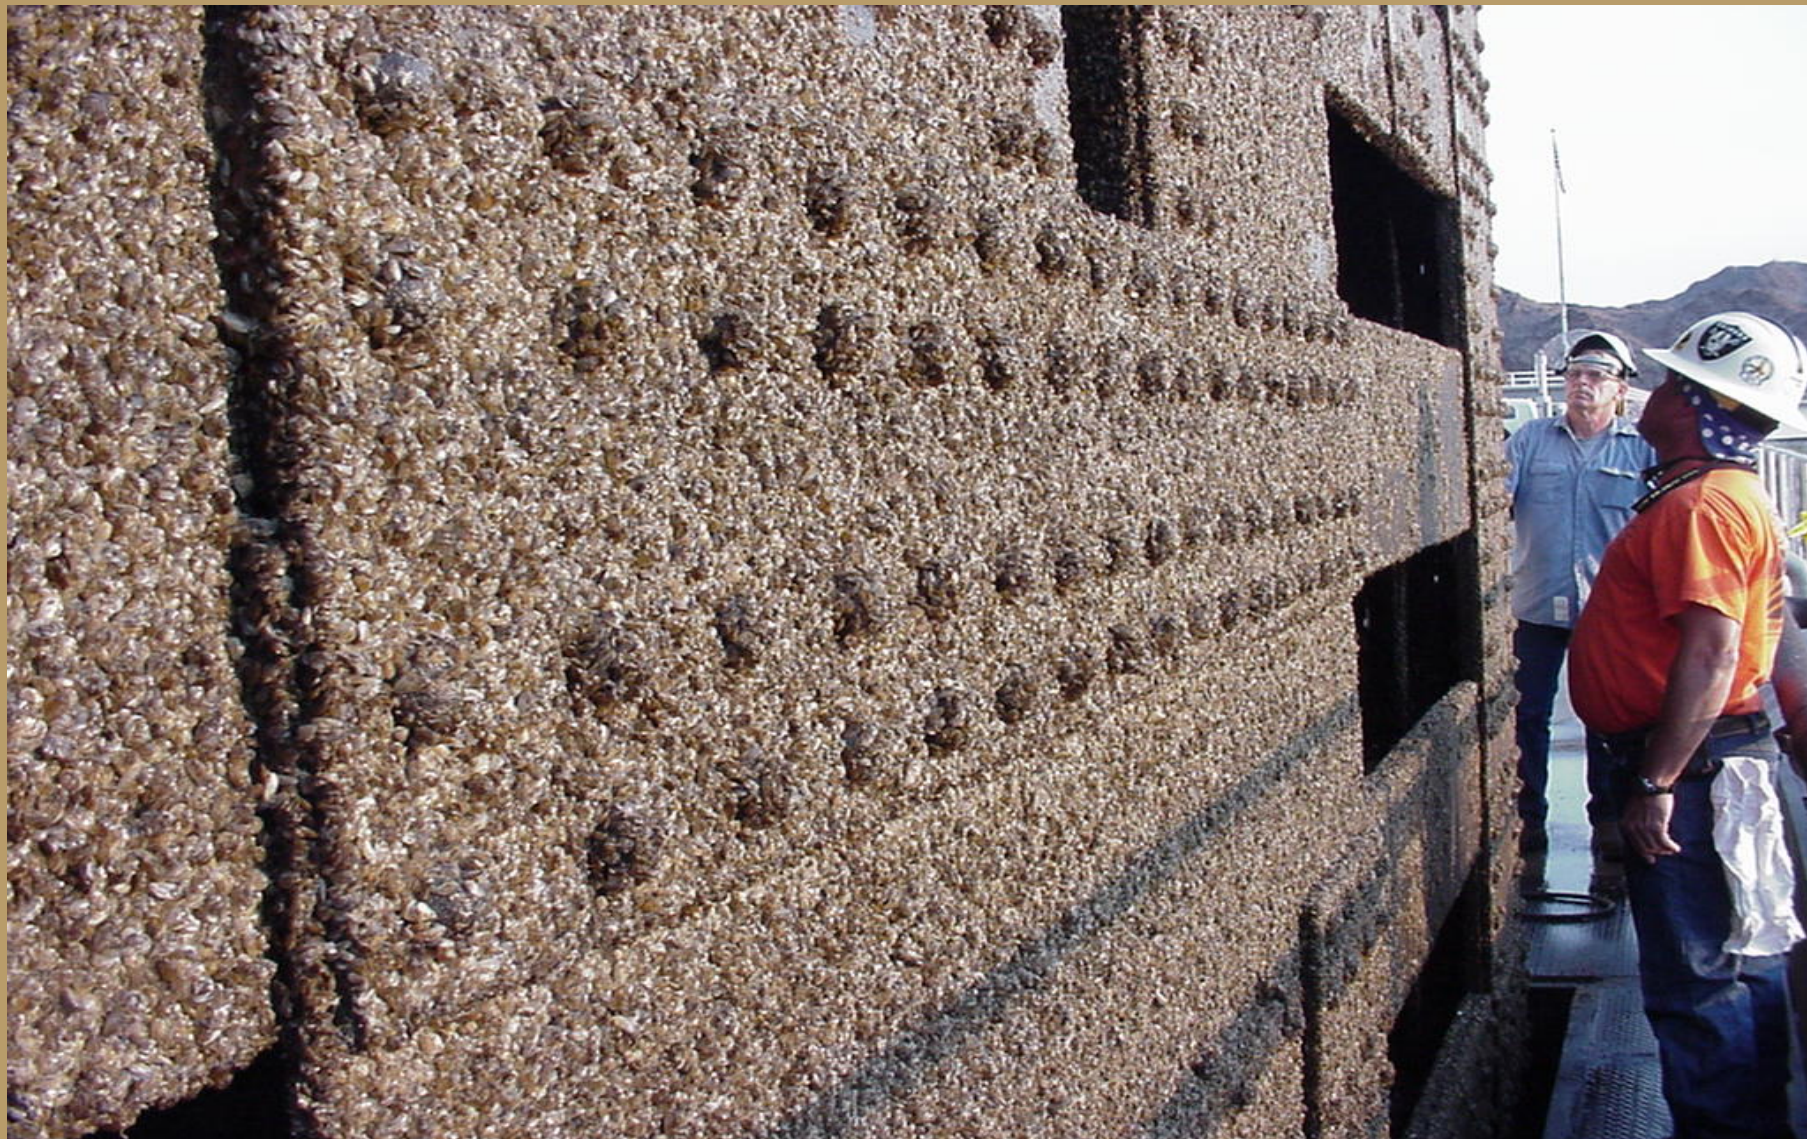
Davis Dam Penstock Gate Oct.07

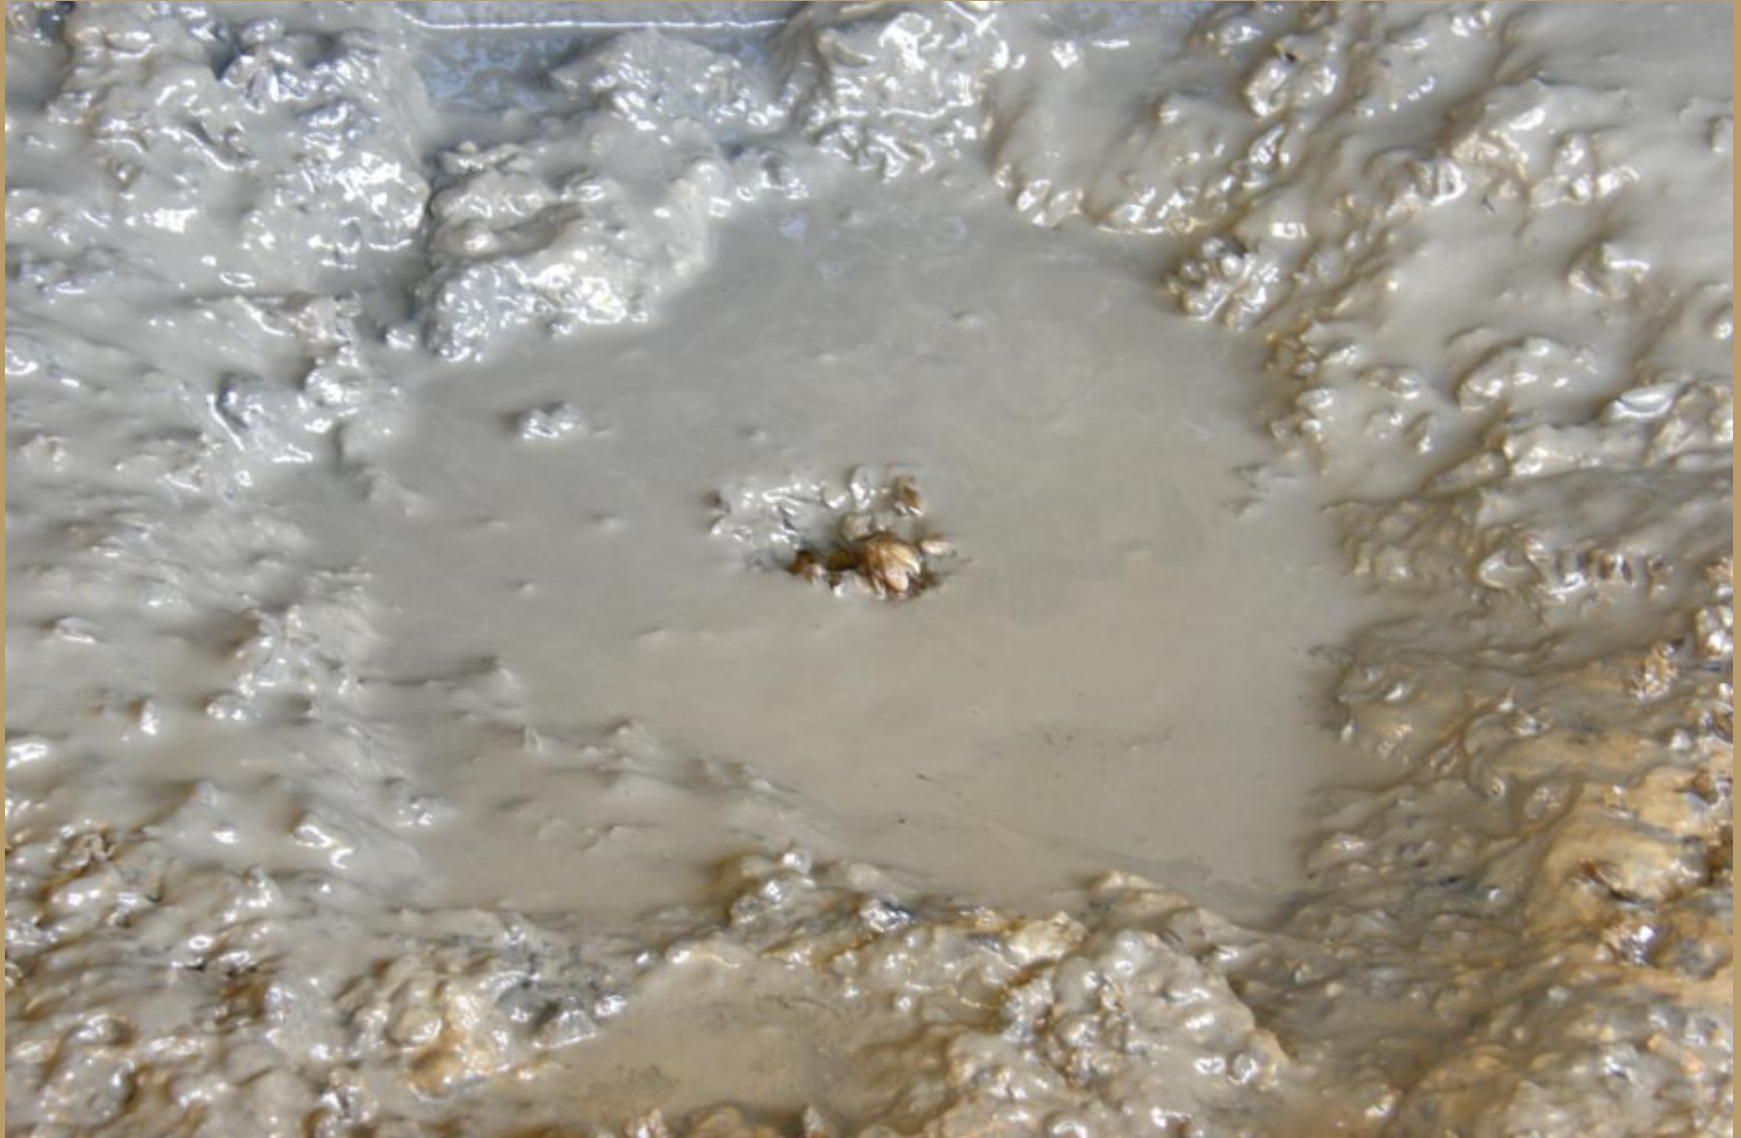
Drain Holes Plugged With Mussels

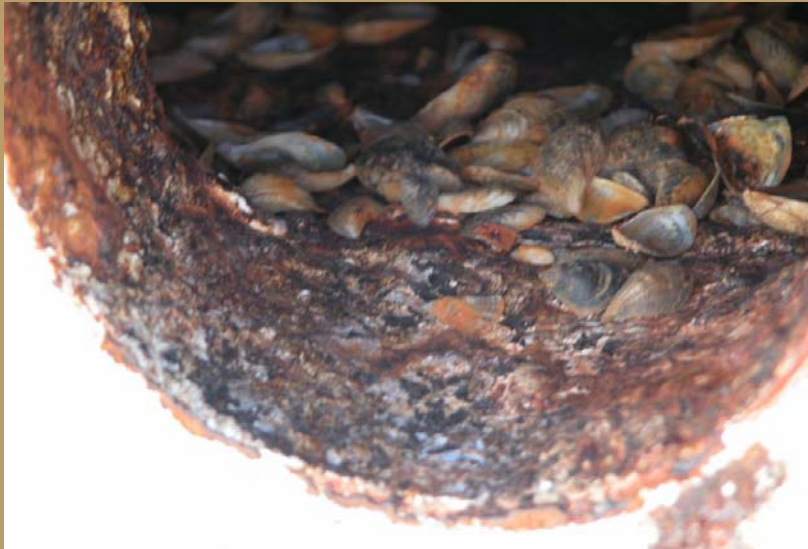
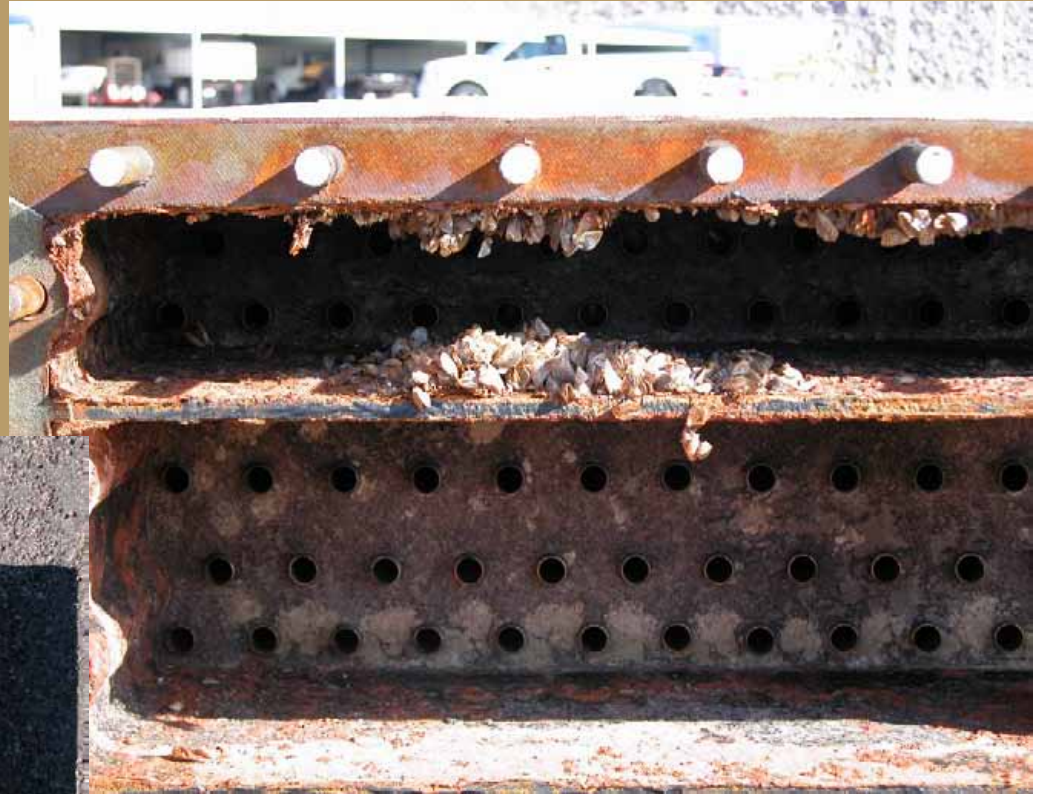
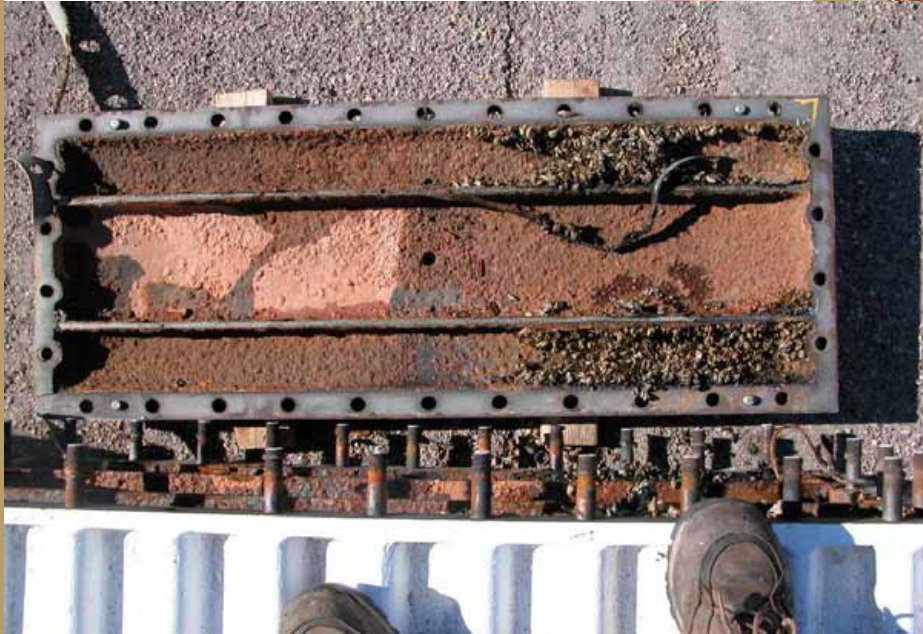
Generator Cooling Water Heat Exchanger Davis Dam Dec 2009

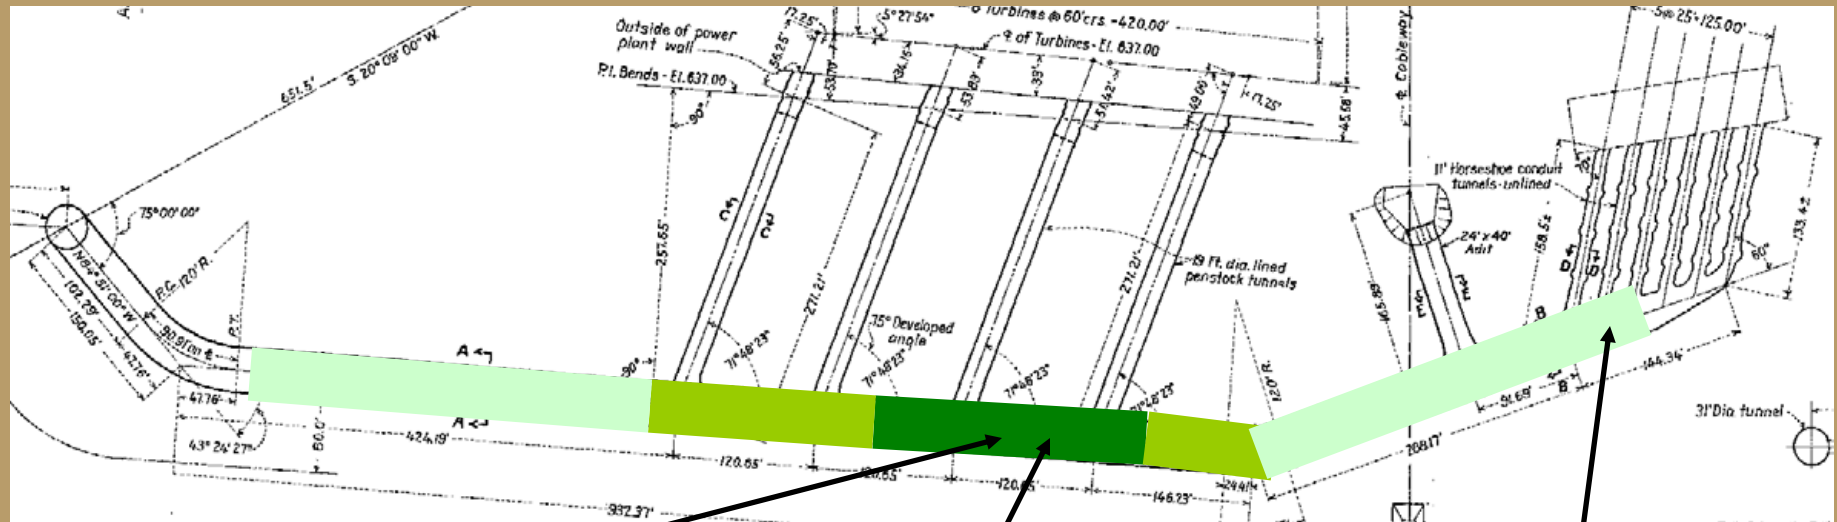
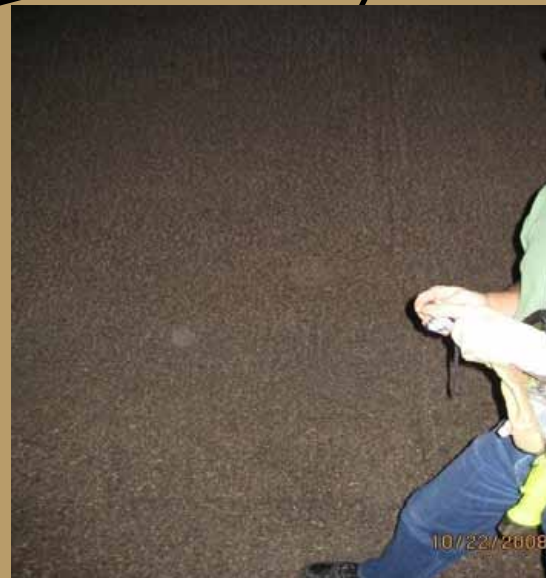
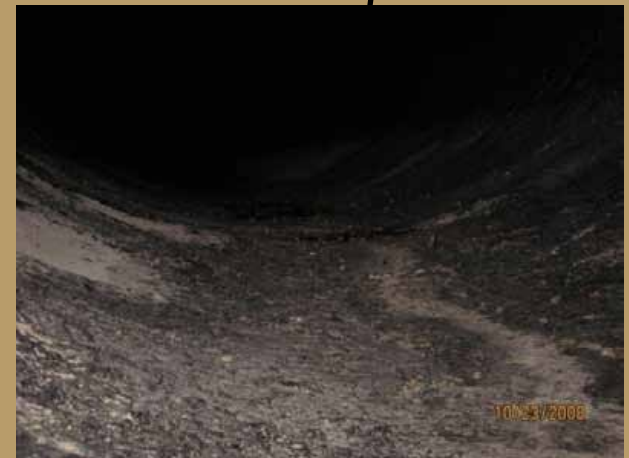
Upper Nevada Penstock

October 2008

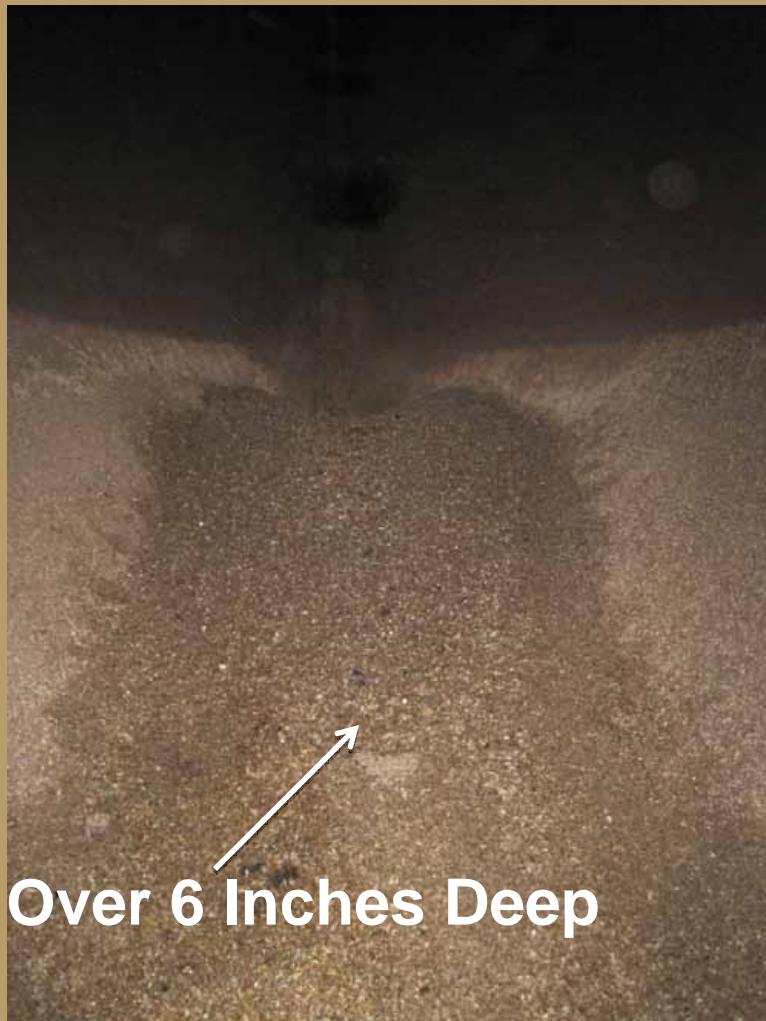
Penstock Lateral Shell Debris
(13ft diameter)

Over 6 Inches Deep

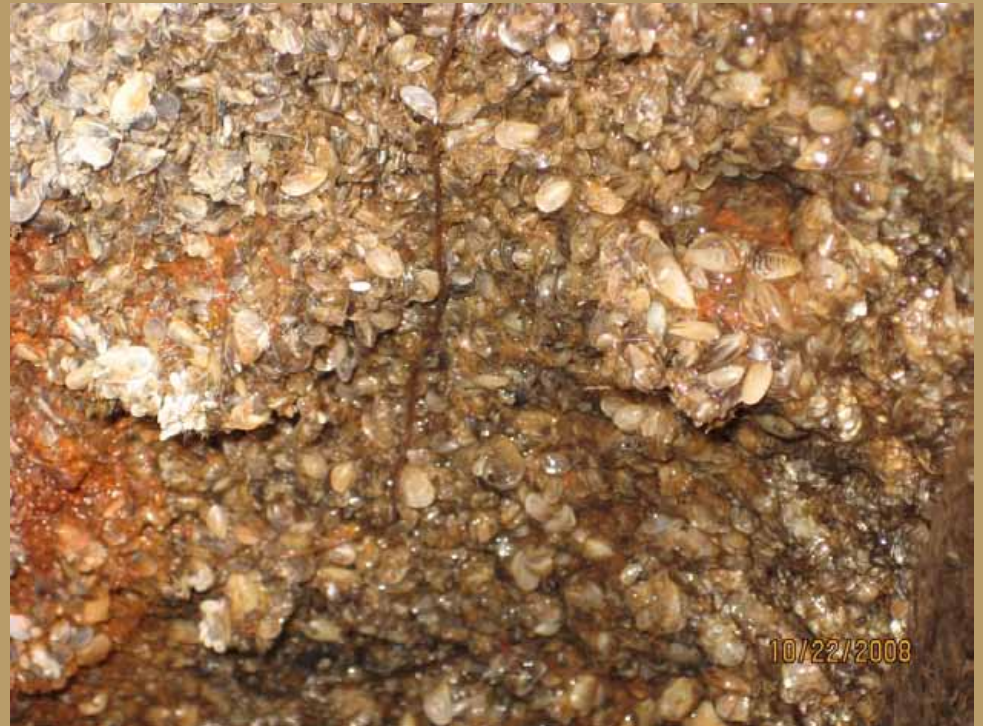
Penstock Drain – Heavy
Settling
