RECLAMATION

Lower Colorado River

**Challenges And Control Activities
For Invasive Mussels**

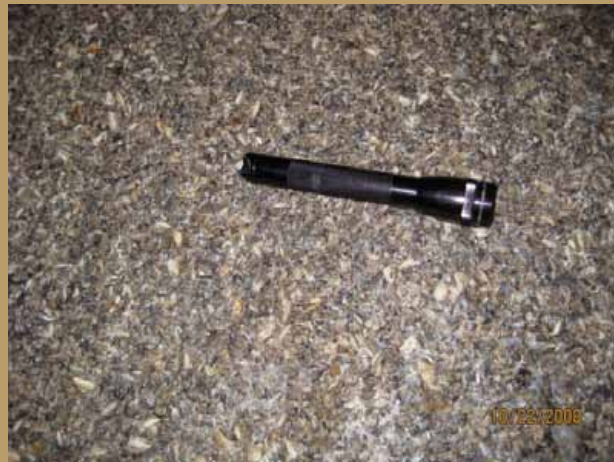
Upper Nevada Penstock

October 2008

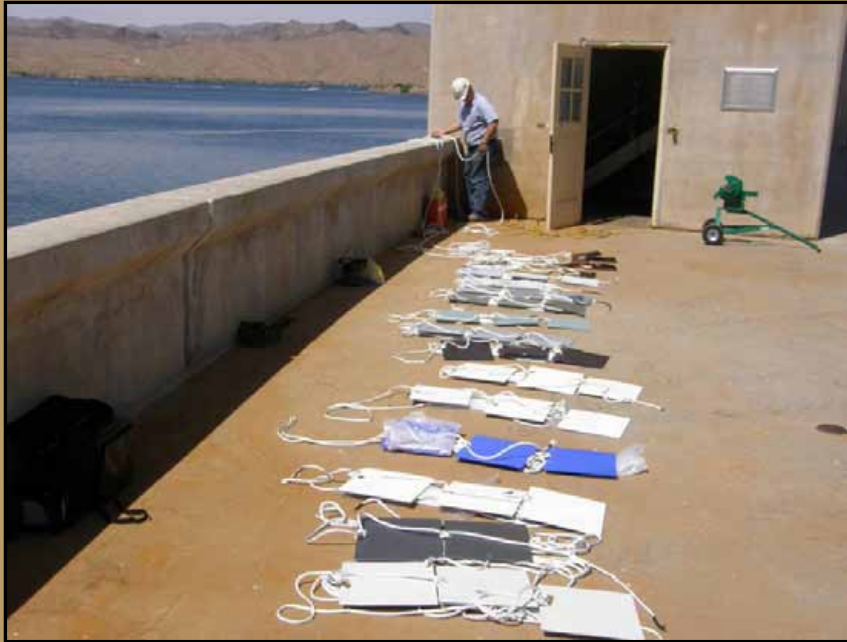
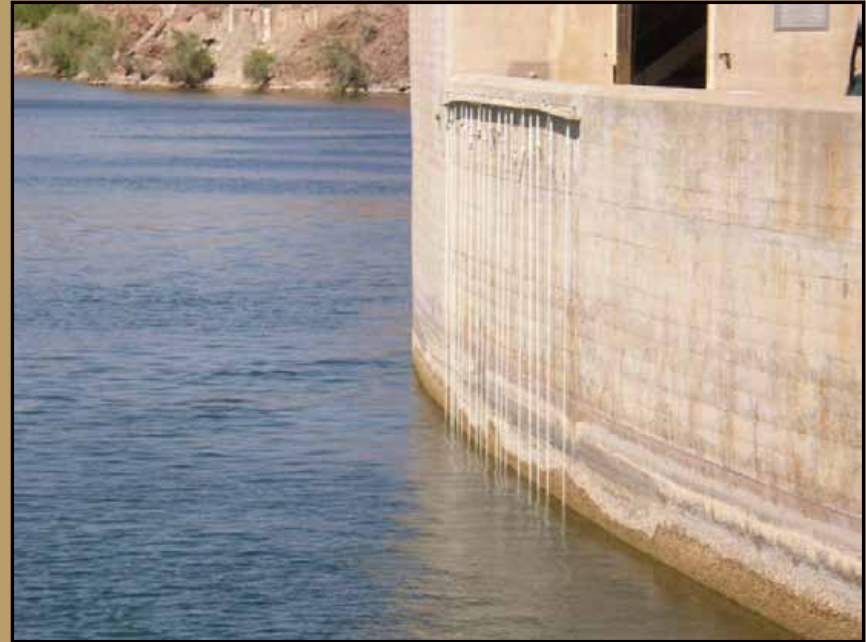
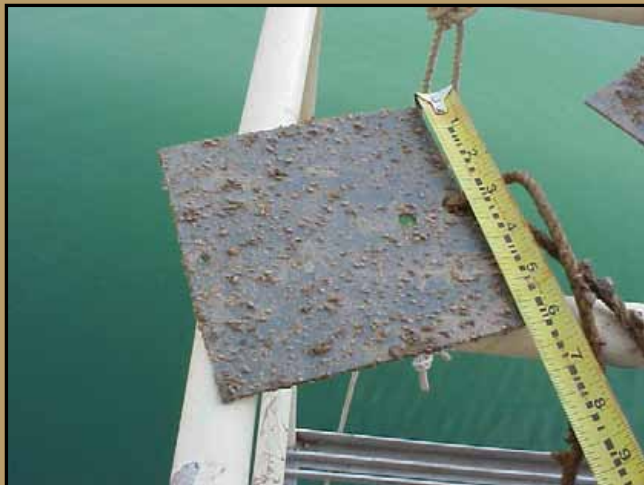
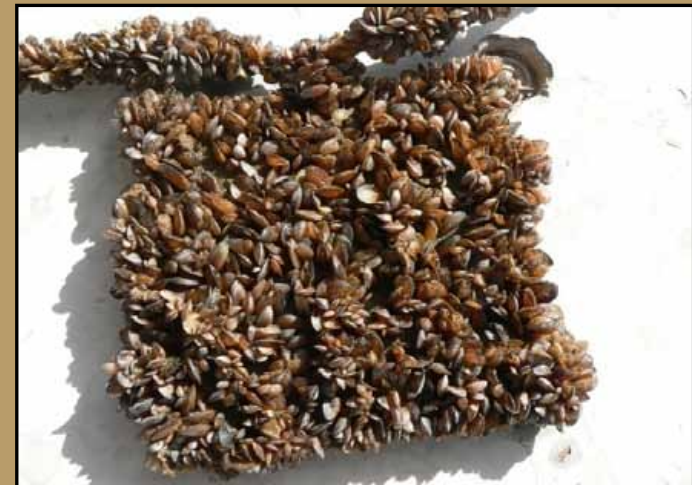
Coatings Panels (cont.)

→
3-month
fouling rate

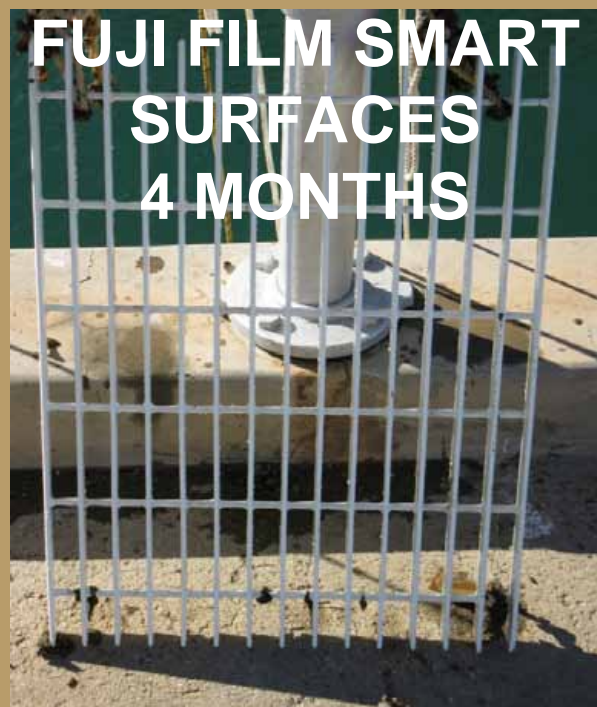
**FUJI FILM SMART
SURFACES
4 MONTHS**

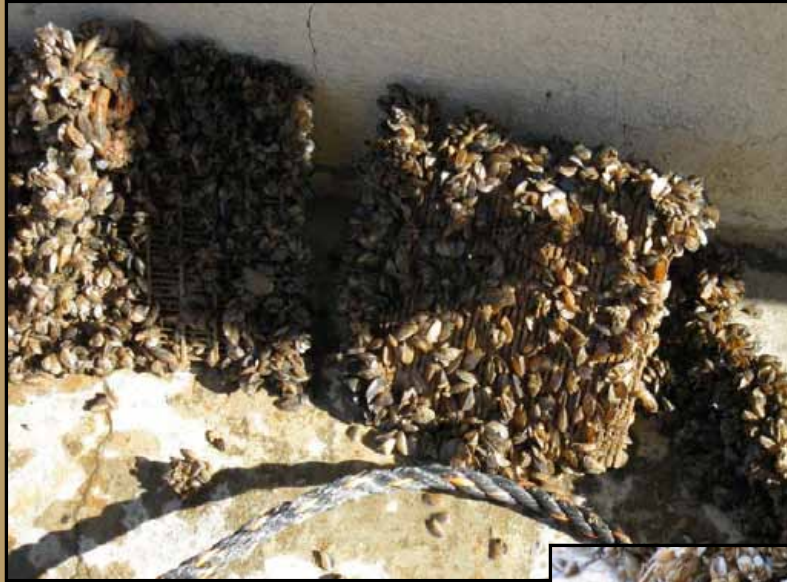
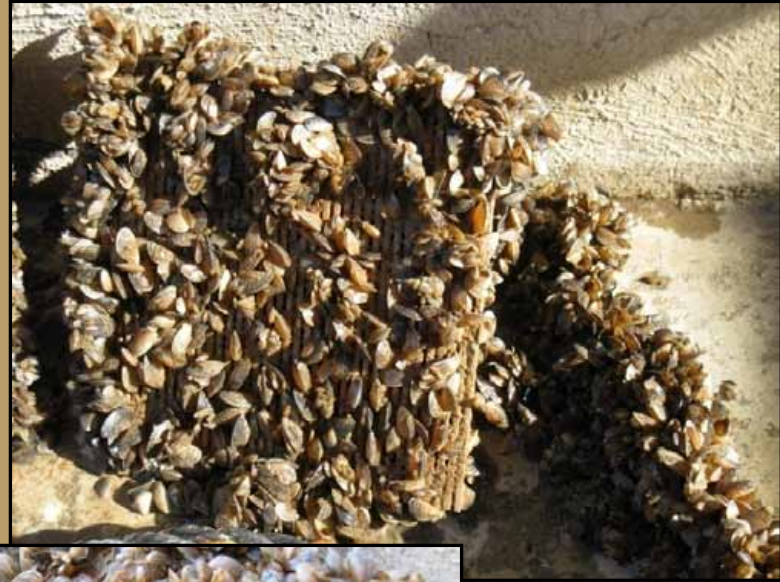
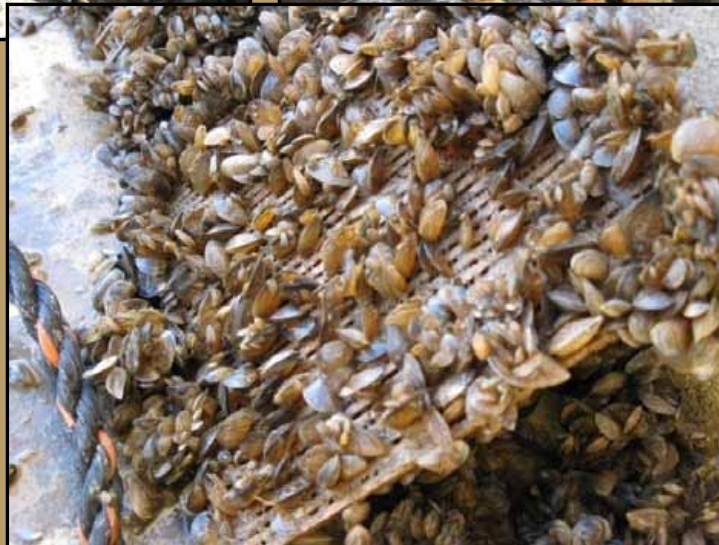
Fish Screen Material (Cu- Ni Wedge Wire)

3-month fouling
(Sept. – Dec. 2009)

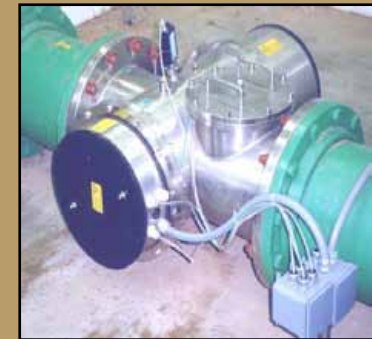
Unit Cooling Water - Current Layout and New Design

UV design lower right corner

New design uses pumps using tail bay water supply instead of fore bay at Hoover Dam
